REPORT NO. 710/58

SIXTH REPORT ON COMPOSITE PLATES

I C - I AND I C - V

THE USE OF INSULATING MATERIAL

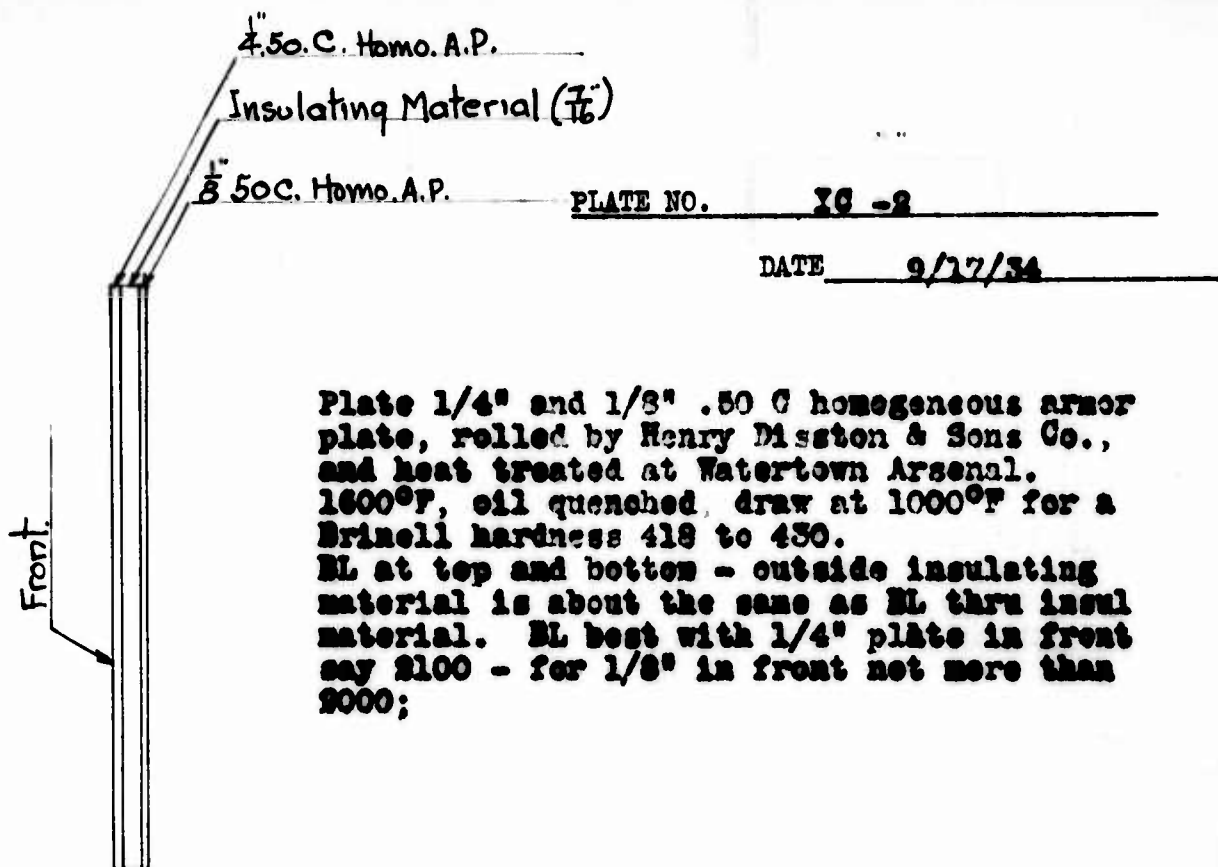
Plate 1/4" and 1/8" .50 C homogeneous armor plate, rolled by Henry Disston & Sons Co., and heat treated at Watertown Arsenal. 1600°F, oil quenched, draw at 1000°F for a Brinell hardness 418 to 430. BL at top and bottom - outside insulating material is about the same as BL thru insul material. BL best with 1/4" plate in front say 2100 - for 1/8" in front not more than 2000;

ROUND NO.	STRIKING VELOCITY	REMARKS
1100 fs. O#2	1	1900	no bulge
*1 1900 fs.	2	2100	above insul. no penetration.
	3	2100	just below insul. slight crack
2100 fs. O#4	4	2100	very slight crack
2100 fs. O#3

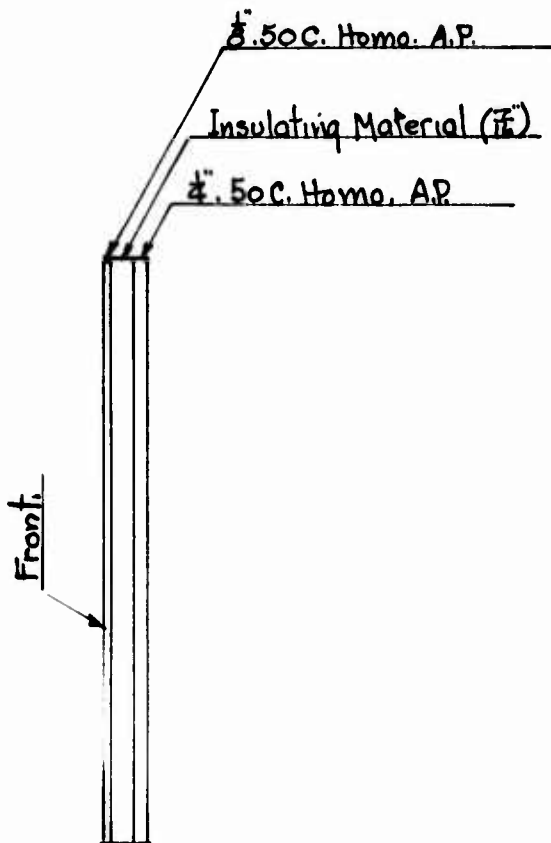
PLATE NO. IC - 1

Plates 1/8" and 1/4" .50 C homogeneous armor plate, rolled by Henry Disston & Sons Co., and heat treated at Watertown Arsenal. 1600°F, oil quenched, drawn at 1000°F for a Brinell hardness of 418 to 430.

<div style="border: 1px solid black; padding: 10px; width: 400px; height: 300px; position: relative;"> <div style="position: absolute; top: 10%; left: 45%;">#3 1900 fs.</div> <div style="position: absolute; top: 35%; left: 30%;">#2 1700 fs.</div> <div style="position: absolute; top: 60%; left: 45%;">#1 1600 fs.</div> <div style="position: absolute; top: 80%; left: 35%;">#4 2100 fs.</div> </div>	ROUND NO.	STRIKING VELOCITY	REMARKS
	1	1600	very slight bulge c.i.p.
	2	1700	"
	3	1900	Bulge on back plate. hit old hole.
	4	2100	c.i.p. hose thin about 1/8"
